Partington Creek , Coquitlam

Source Controls in Poorly Draining Soils

Laurel Morgan, M.Sc., P.Eng., P.E.

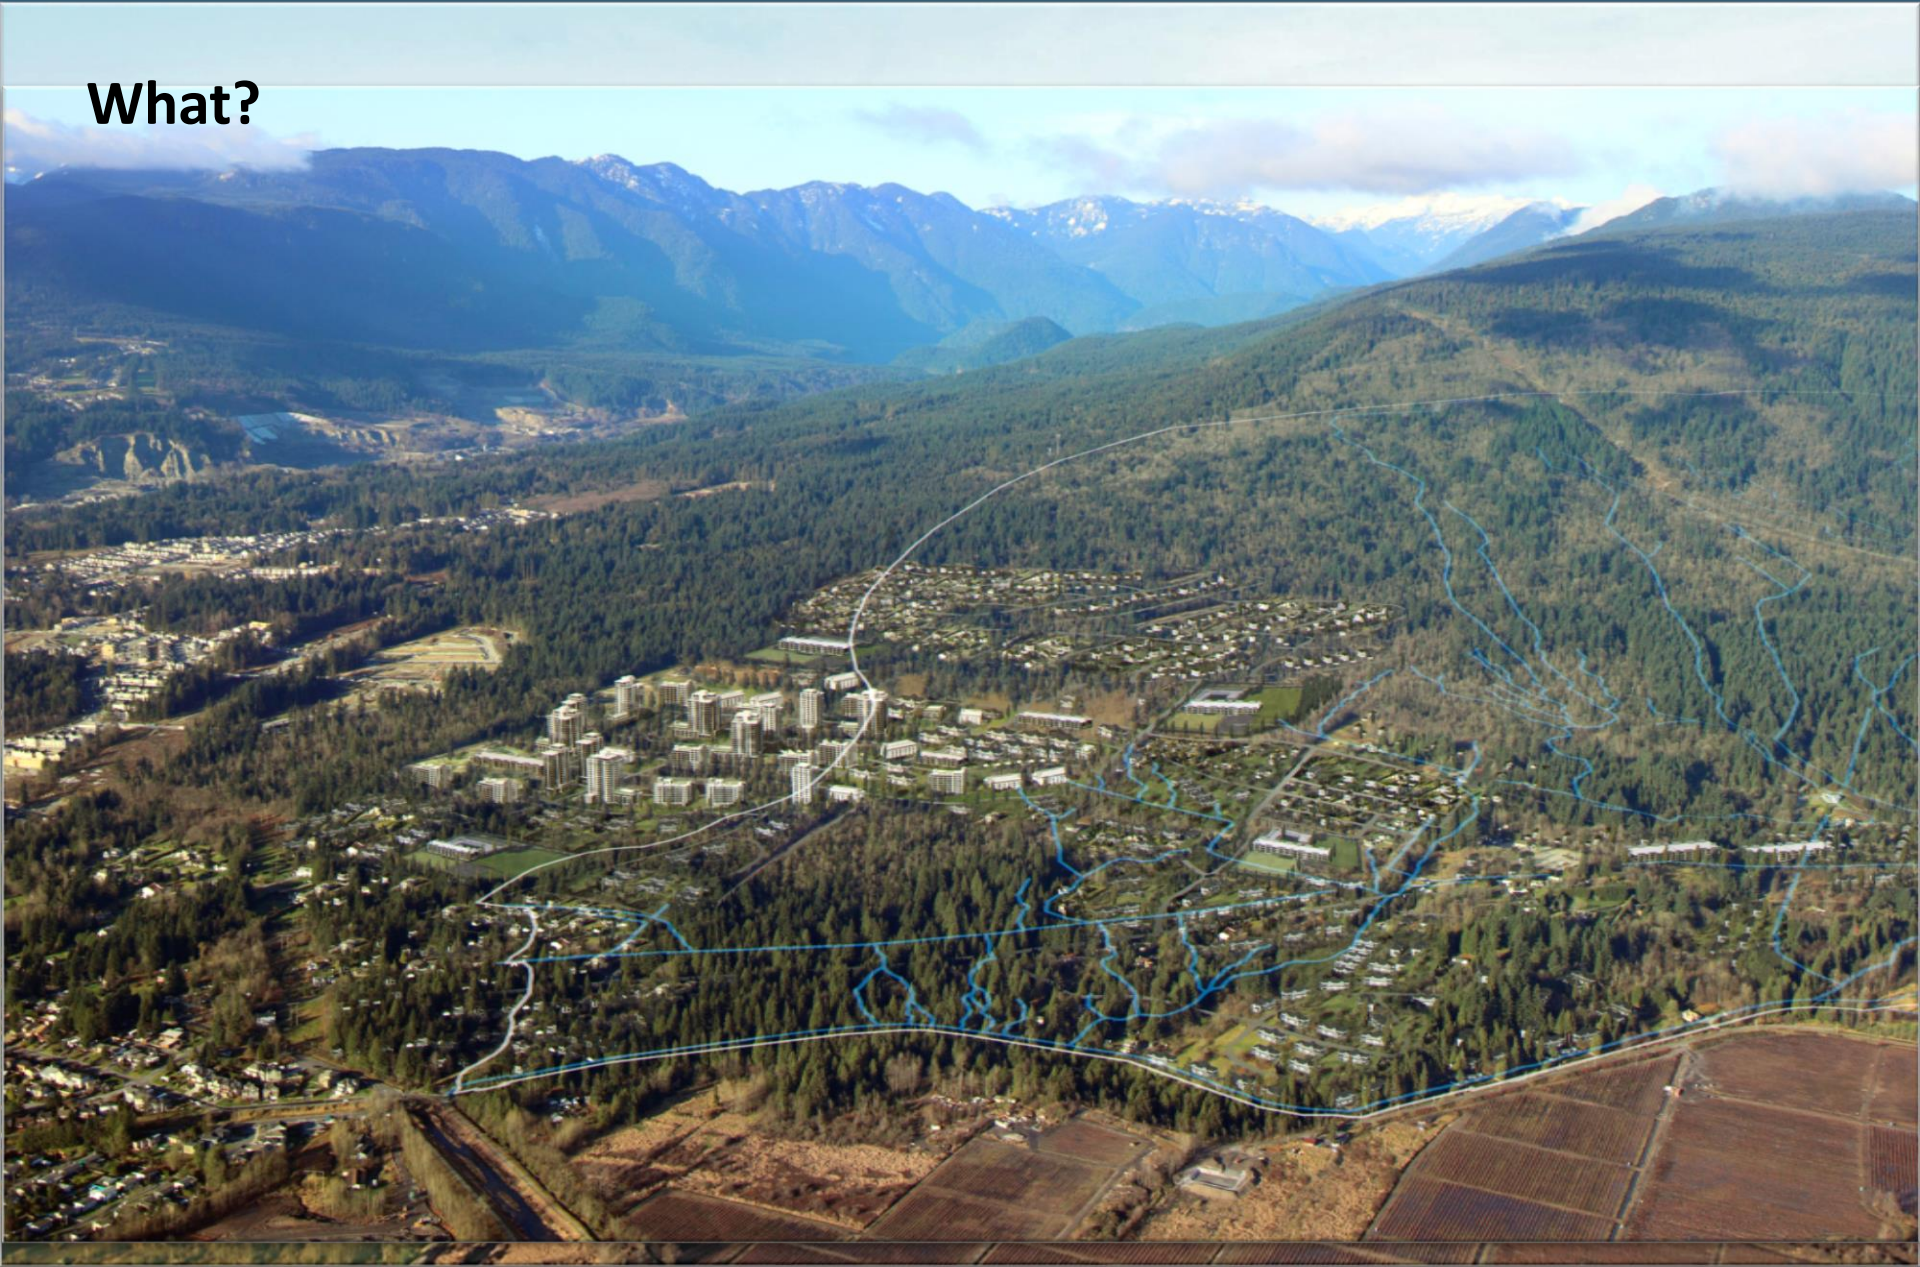
SIMULATED TYPICAL-YEAR HYDROGRAPHS

- 80% Impervious
- 40% Impervious
- 10% Impervious
- 0% Impervious

Time (30 Minute Interval, January to January)

Hydrographs taken from XP-SWMM rainfall-runoff simulation for Thain Creek drainage basin using 1968 North Vancouver rainfall data

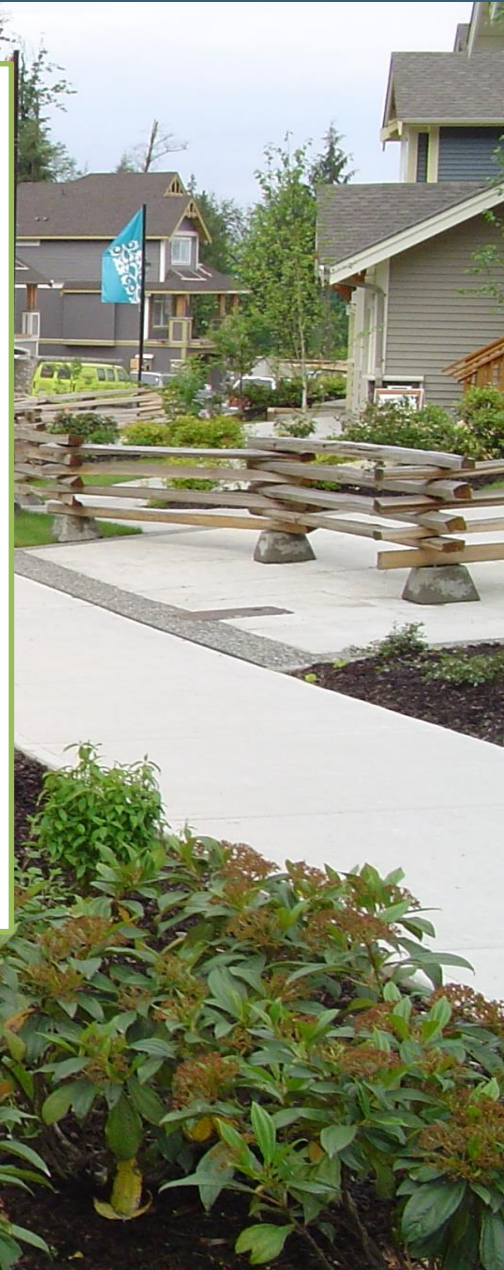
WQ TREATMENT – Mature Roadside Rain Gardens

**Water Quality Monitoring 8 yrs after Construction
(2012-2014)**

Statistically Significant:

92% Reduction in TSS (strong)

Reduction in Metals (strong)

Reduction in TKN, TP, TOC (weak)

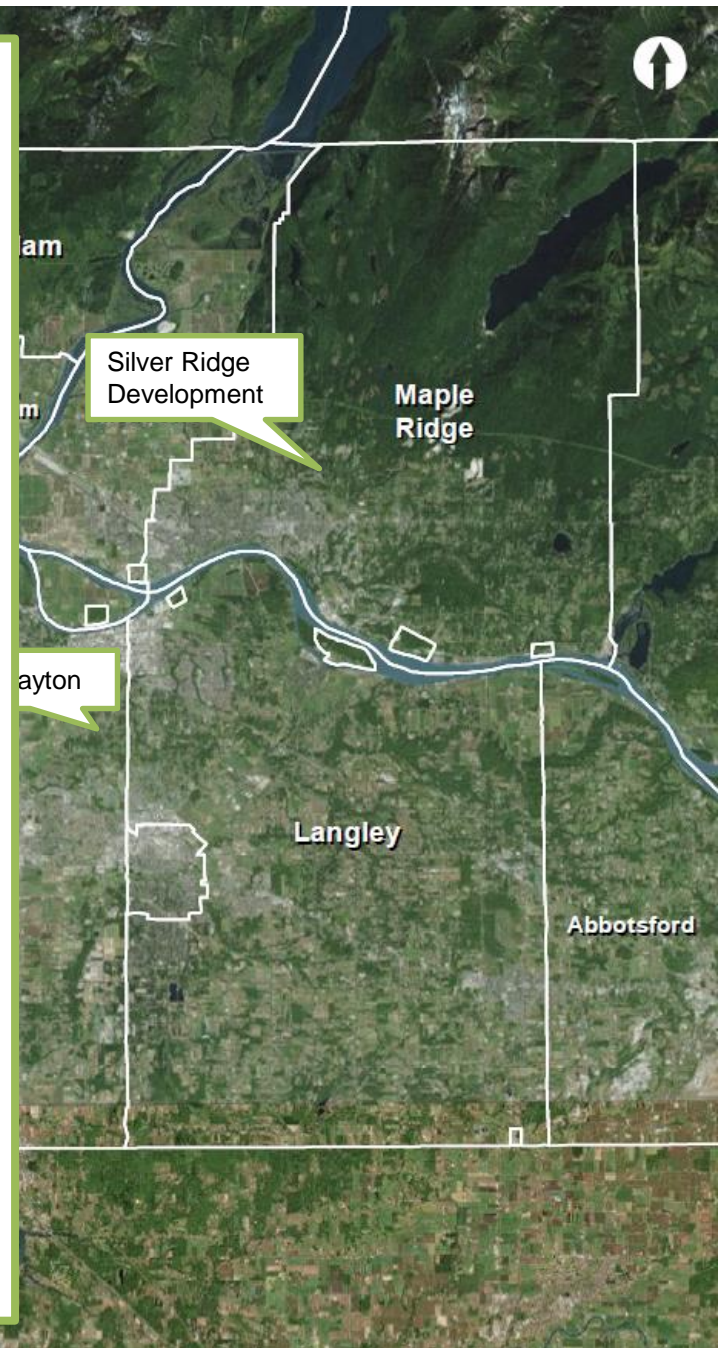
East Clayton Development

Treatment (Pre-Development with Curb & Gutter)

Disconnected Roof Leader (on Lot)

Absorbent Landscaping (on Lot)

Rock Trench (on Lot)

Detention Pond (Catchment)

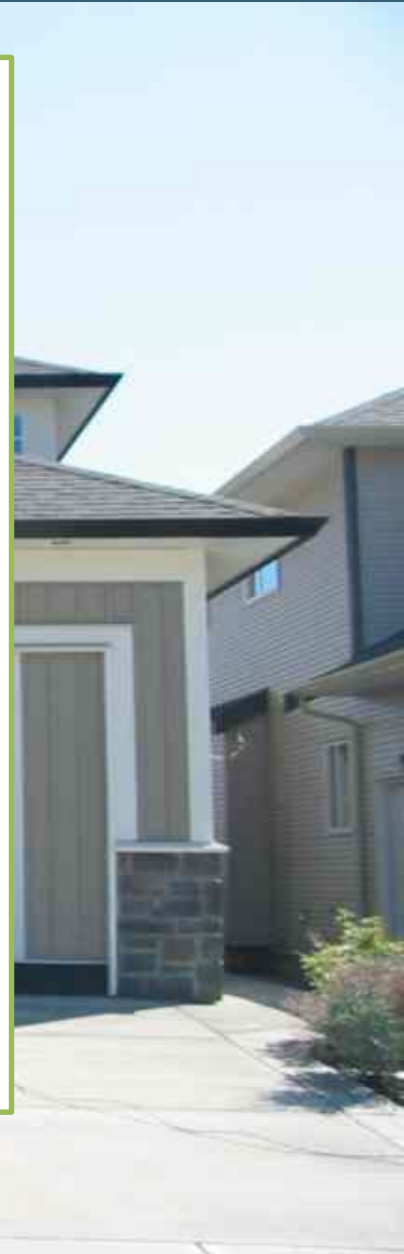
VOLUME REDUCTION AND DETENTION.

3 years of Monitoring 2003-2006

Infiltration Rate/Exfiltration Rate: 0.8 mm/hr

Rock Trench Design: Effective Detention

Absorbent Landscape: **Effective Volume Reduction**
