## CRISIS on Salmon Migration at French Bar Canyon!

## Model Development for Wall Undercutting

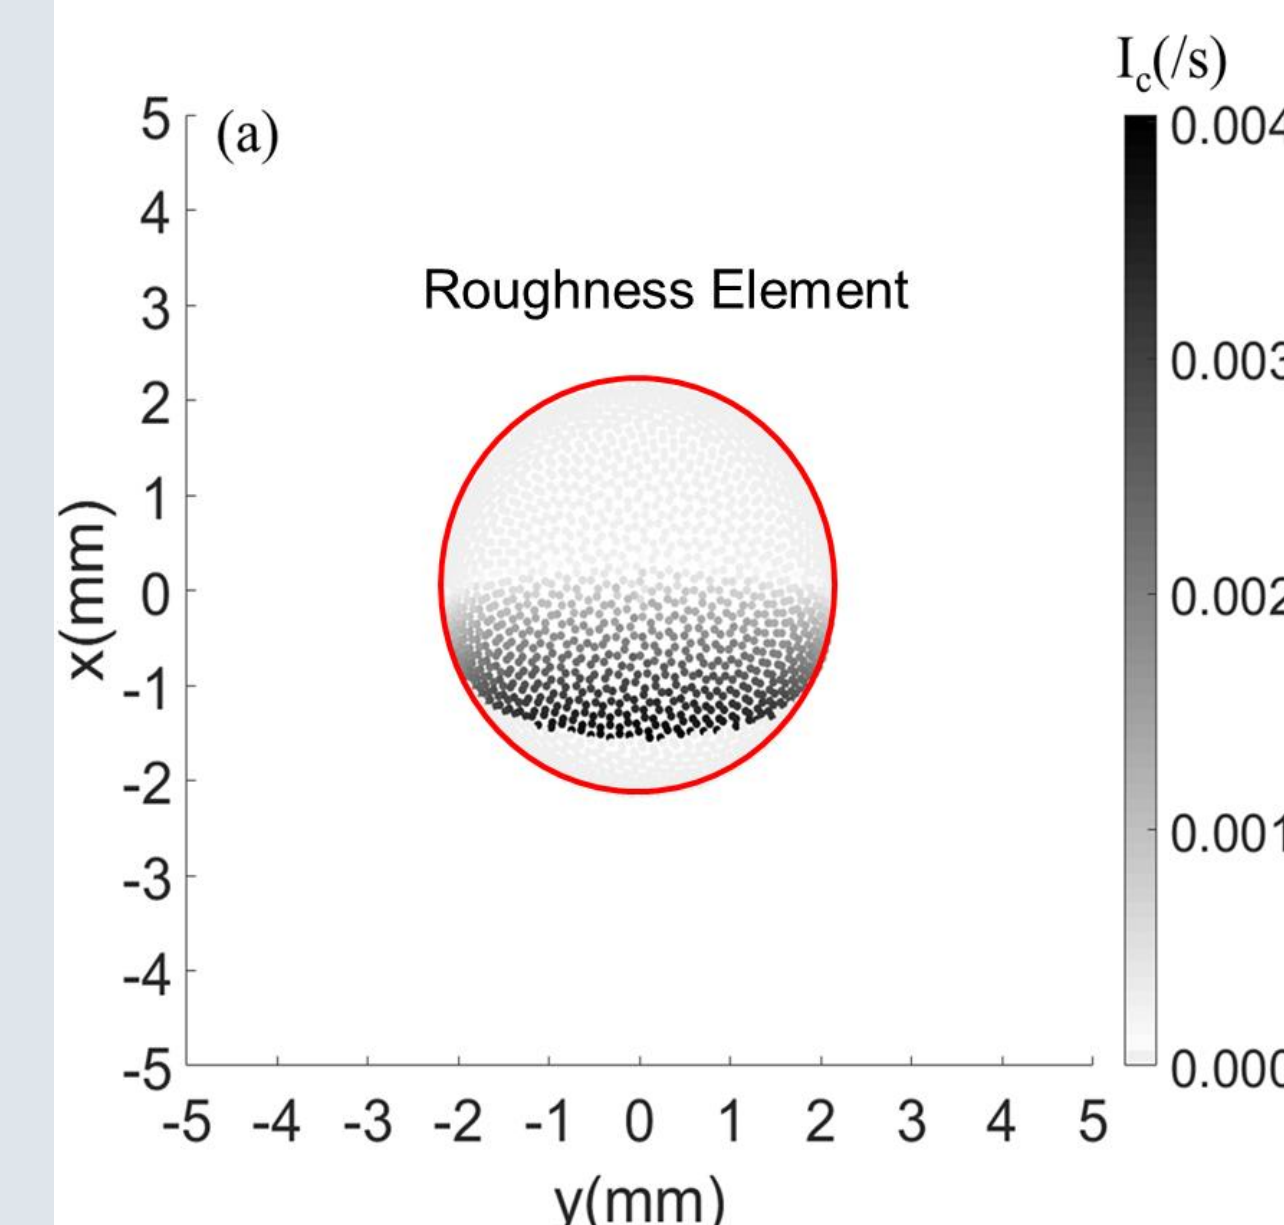
Figure 4. Distribution of impact rates on each grid cell of roughness elements

- 3) Deflection Rates

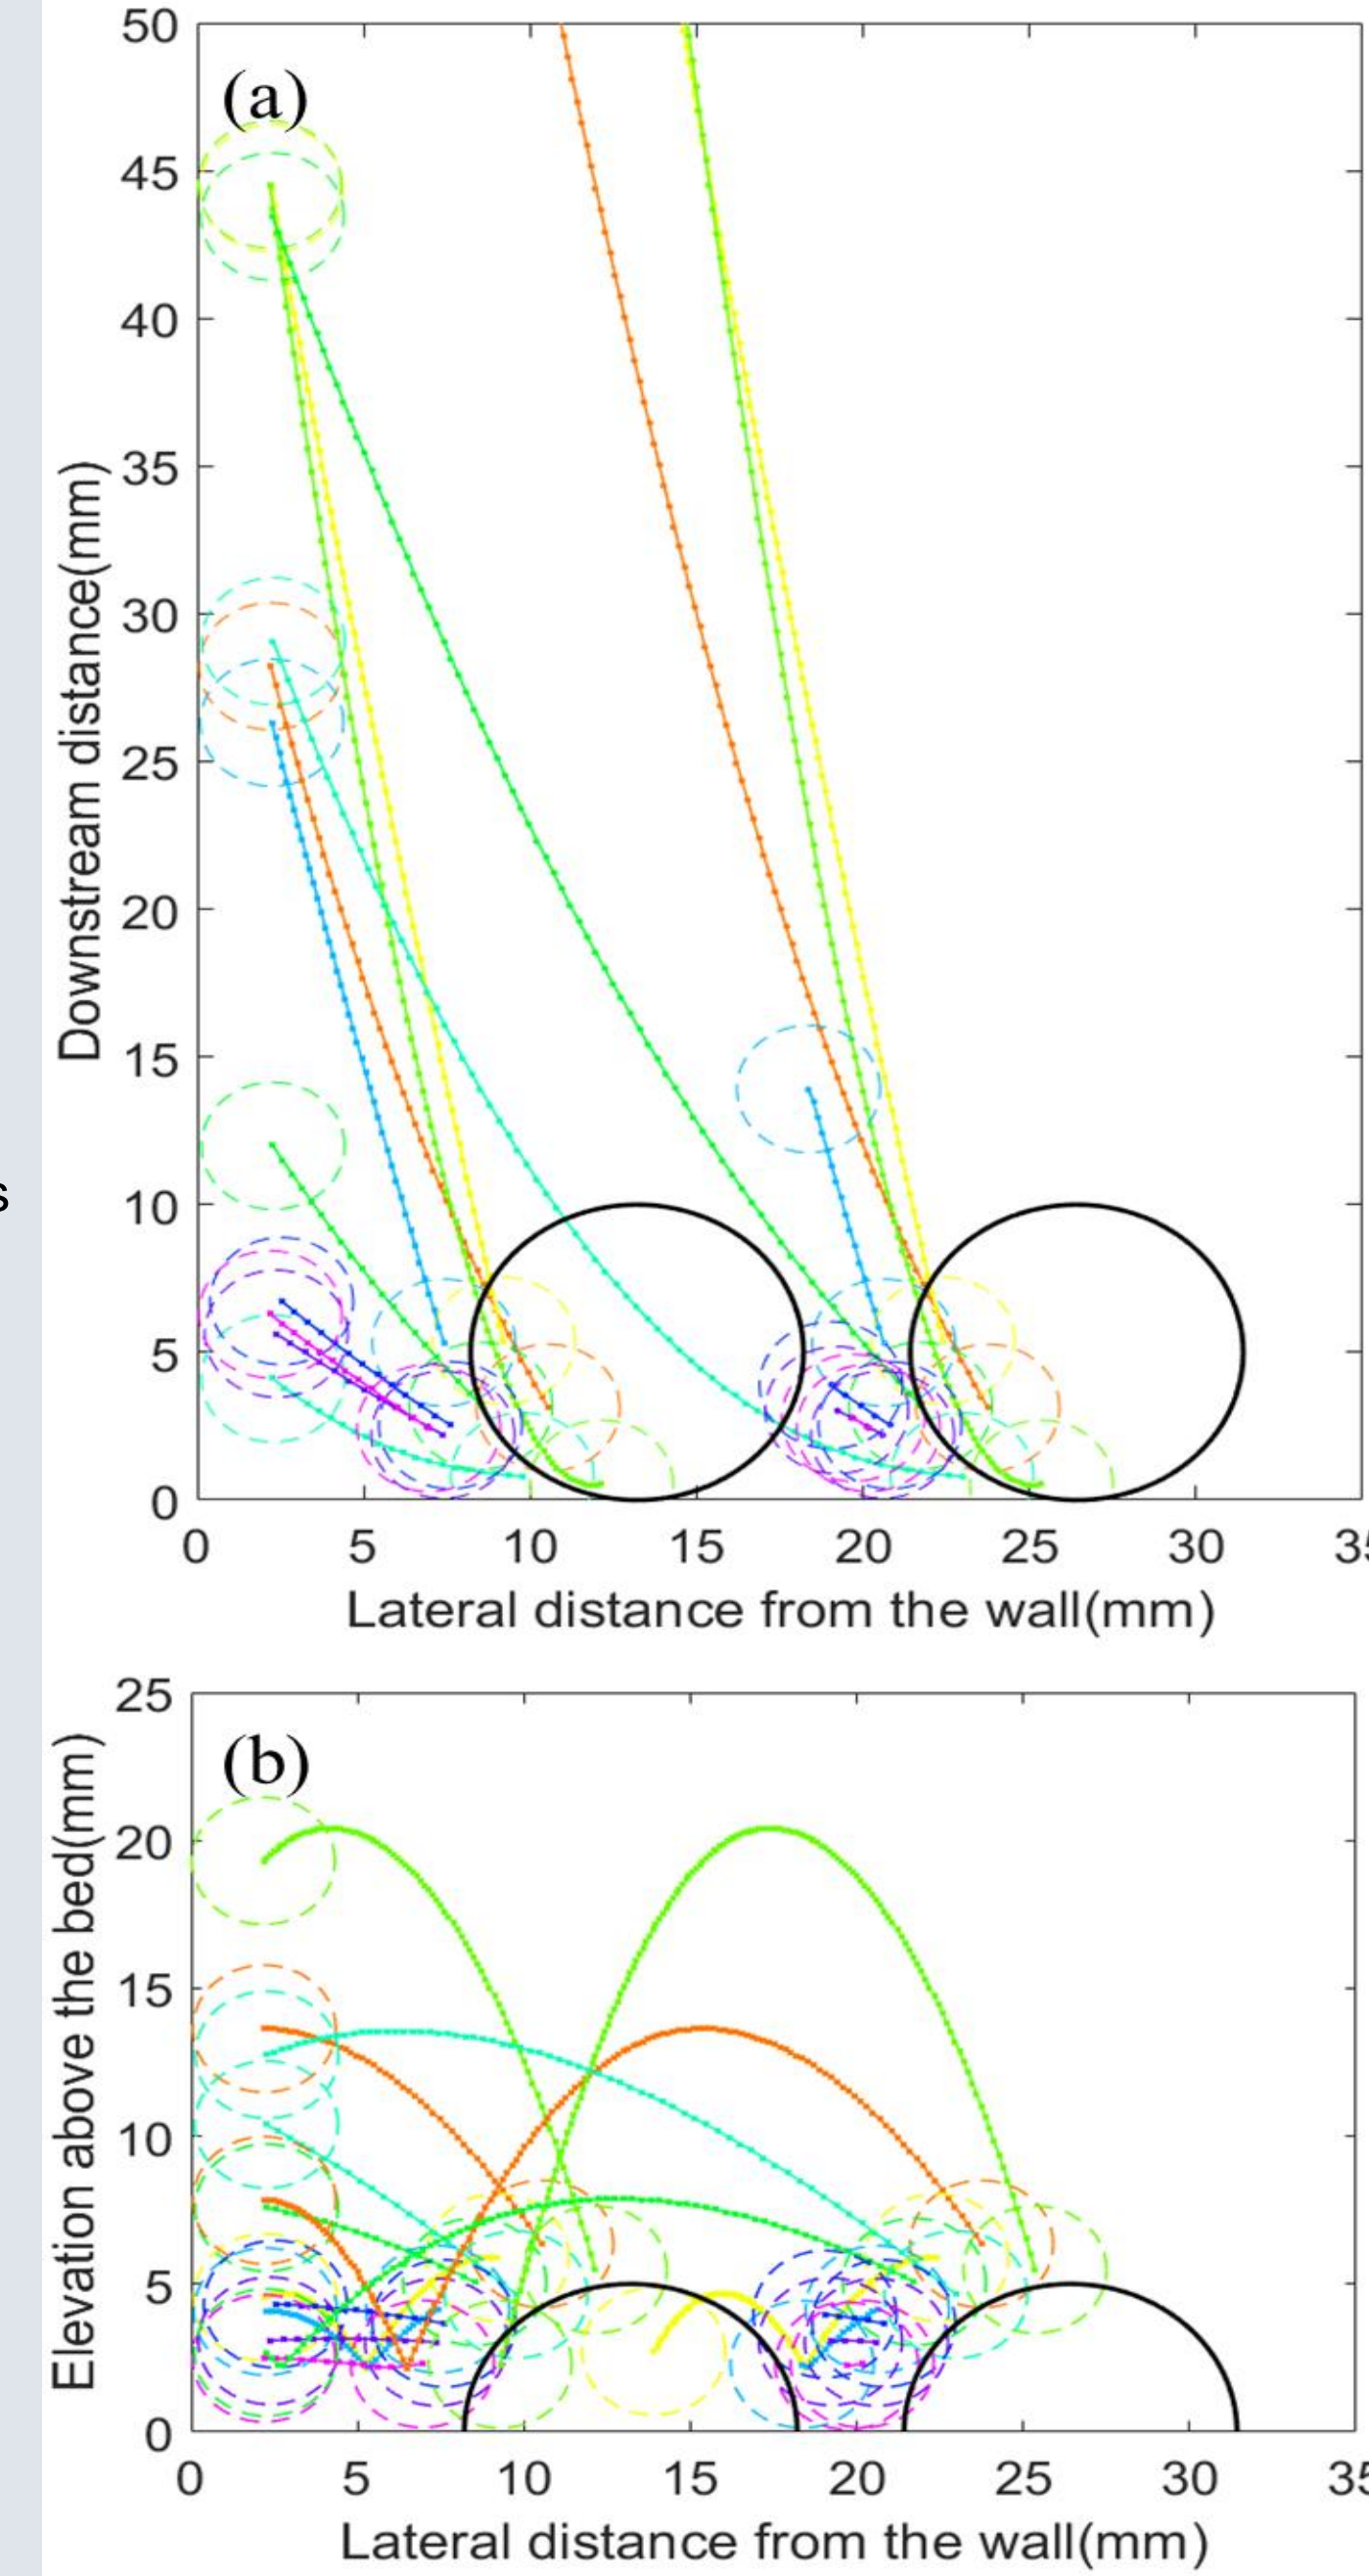
Figure 5. a) Plan view and b) downstream view of the deflection trajectories of bedload particles

- 4) Movement after deflection

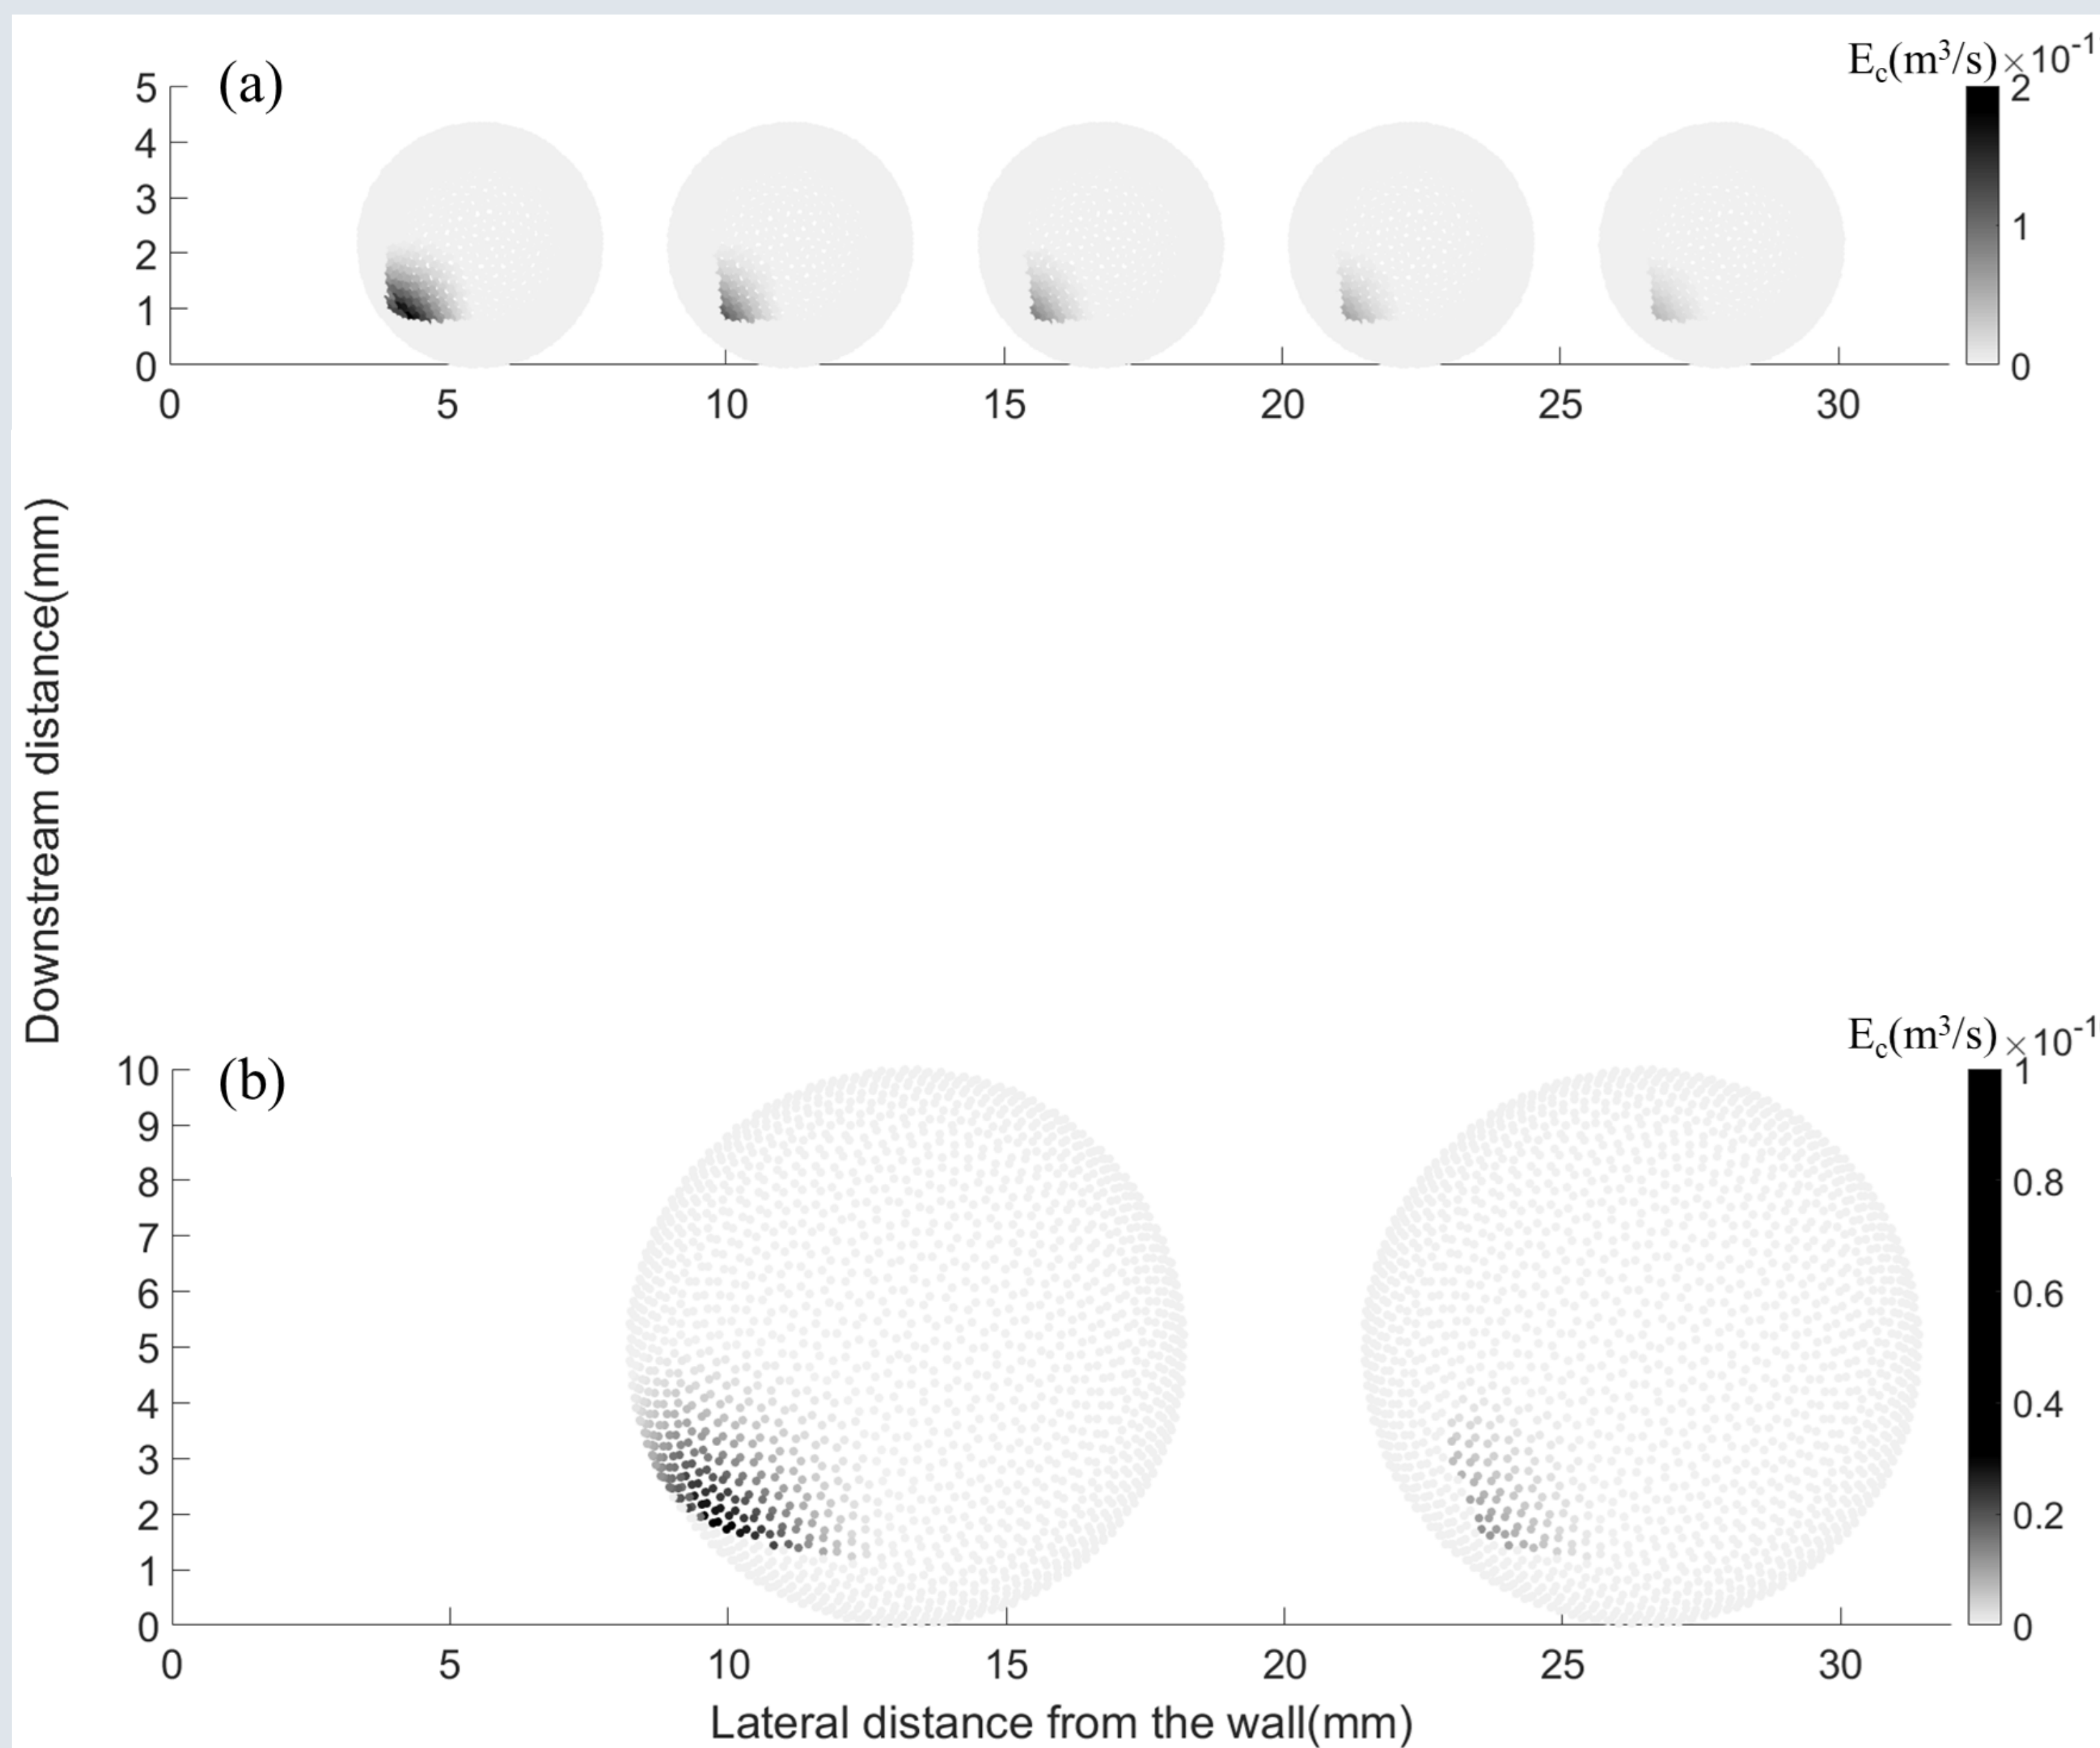
Figure 6. Variation of lateral erosion rate with each grid cell on the a) 4.3 mm roughness elements and b) 10.0 mm roughness elements using inputs from the Fuller et al. (2016) experiments.

- 5) Calculation of lateral erosion rate

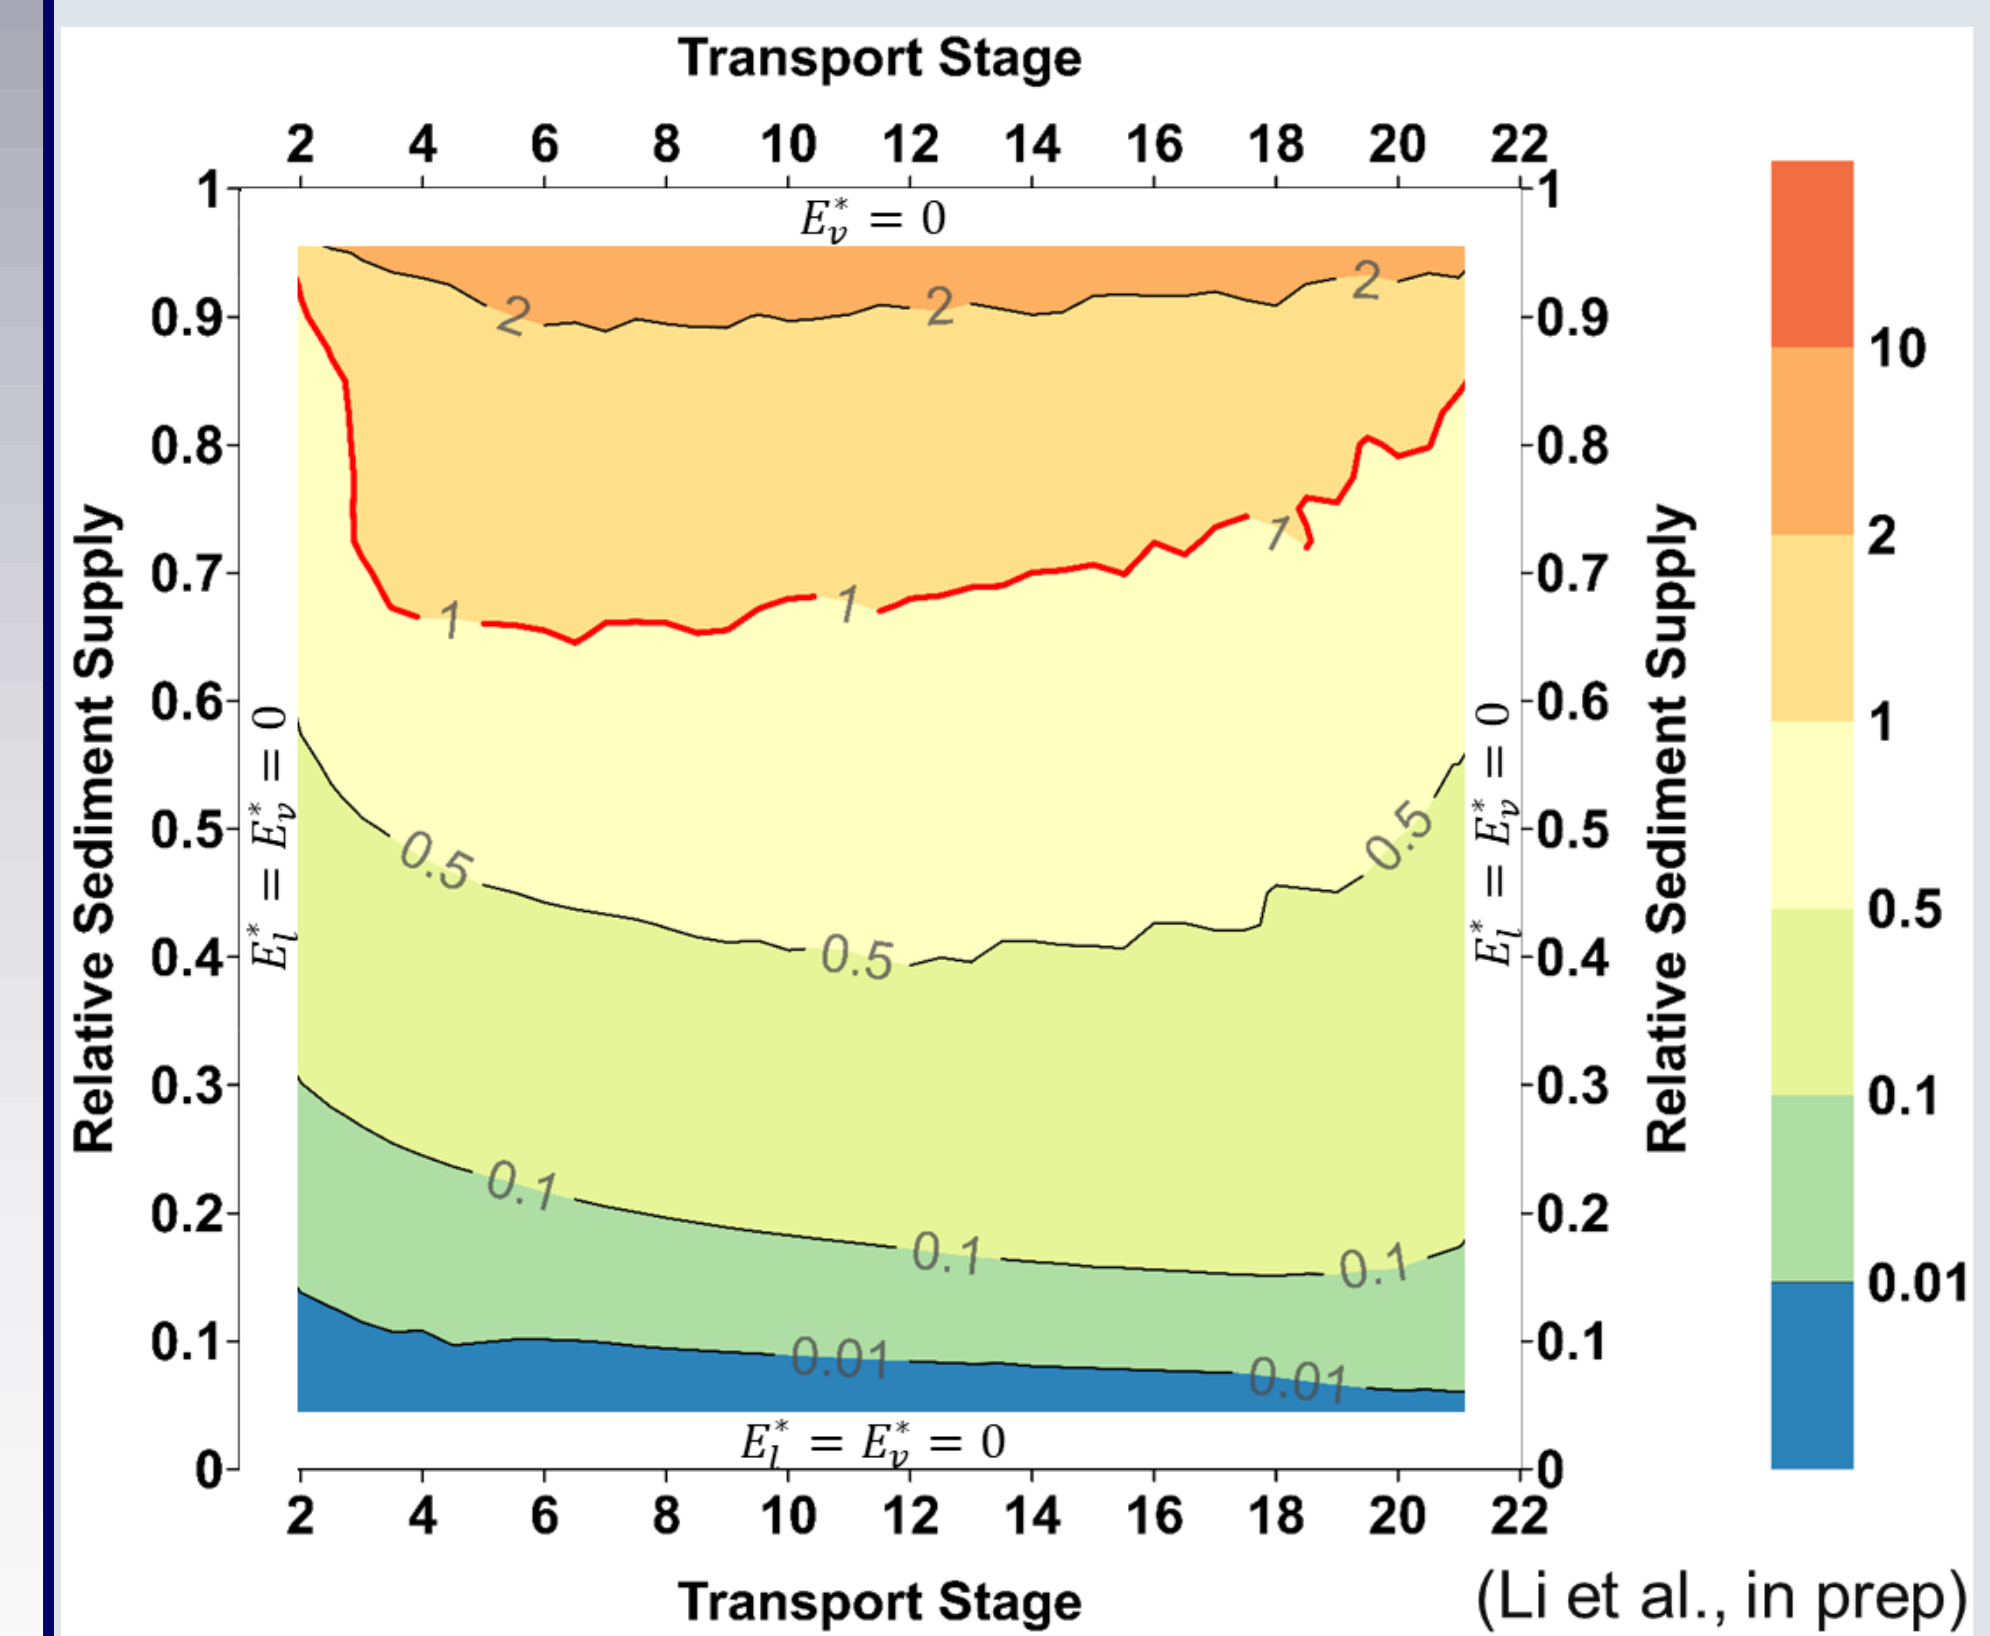
Figure 10. The ratio of lateral to vertical erosion rate as a function of transport stage and relative sediment supply.

- 1) The ratio of lateral to vertical erosion rate monotonically increases with increasing relative sediment supply rate
- 2) Lateral erosion rate is lower than vertical erosion rate under nearly 75% of the transport and supply conditions

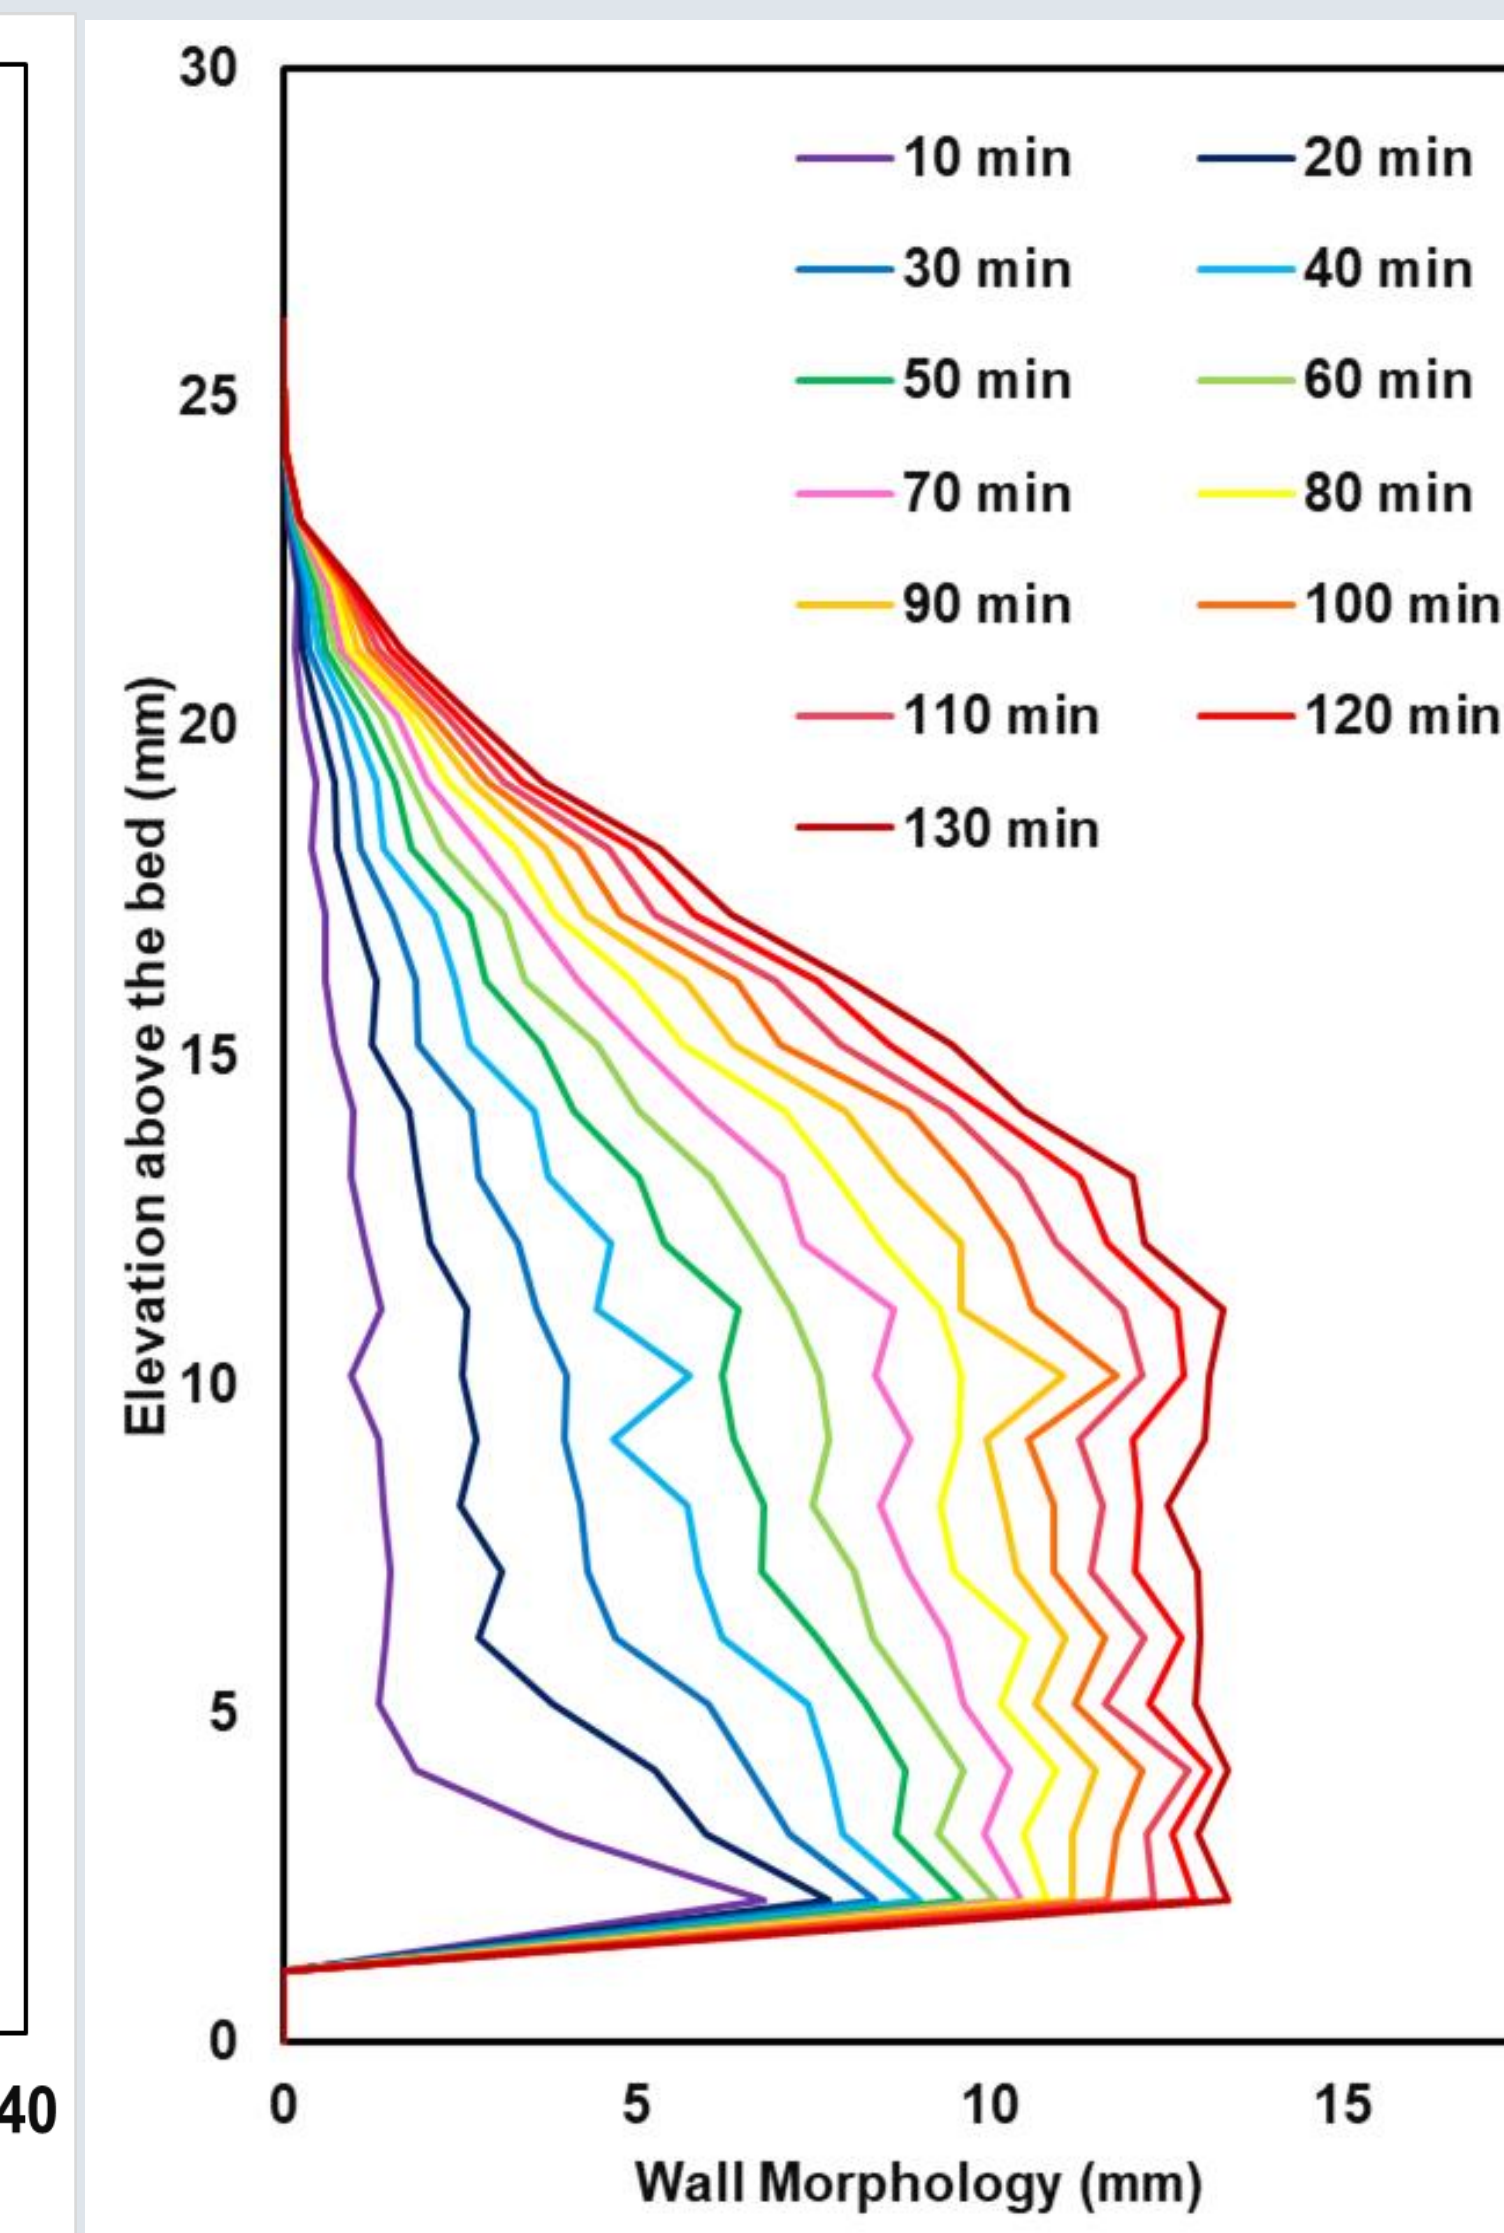
Figure 9. Undercut wall evolution over 2.15 hours
